**AEC Investigation of Cobalt-60 Exposure
at the
Variable Dose Rate Irradiation Facility, UT-AEC**

(Report of Investigating Committee)

February 4, 1971

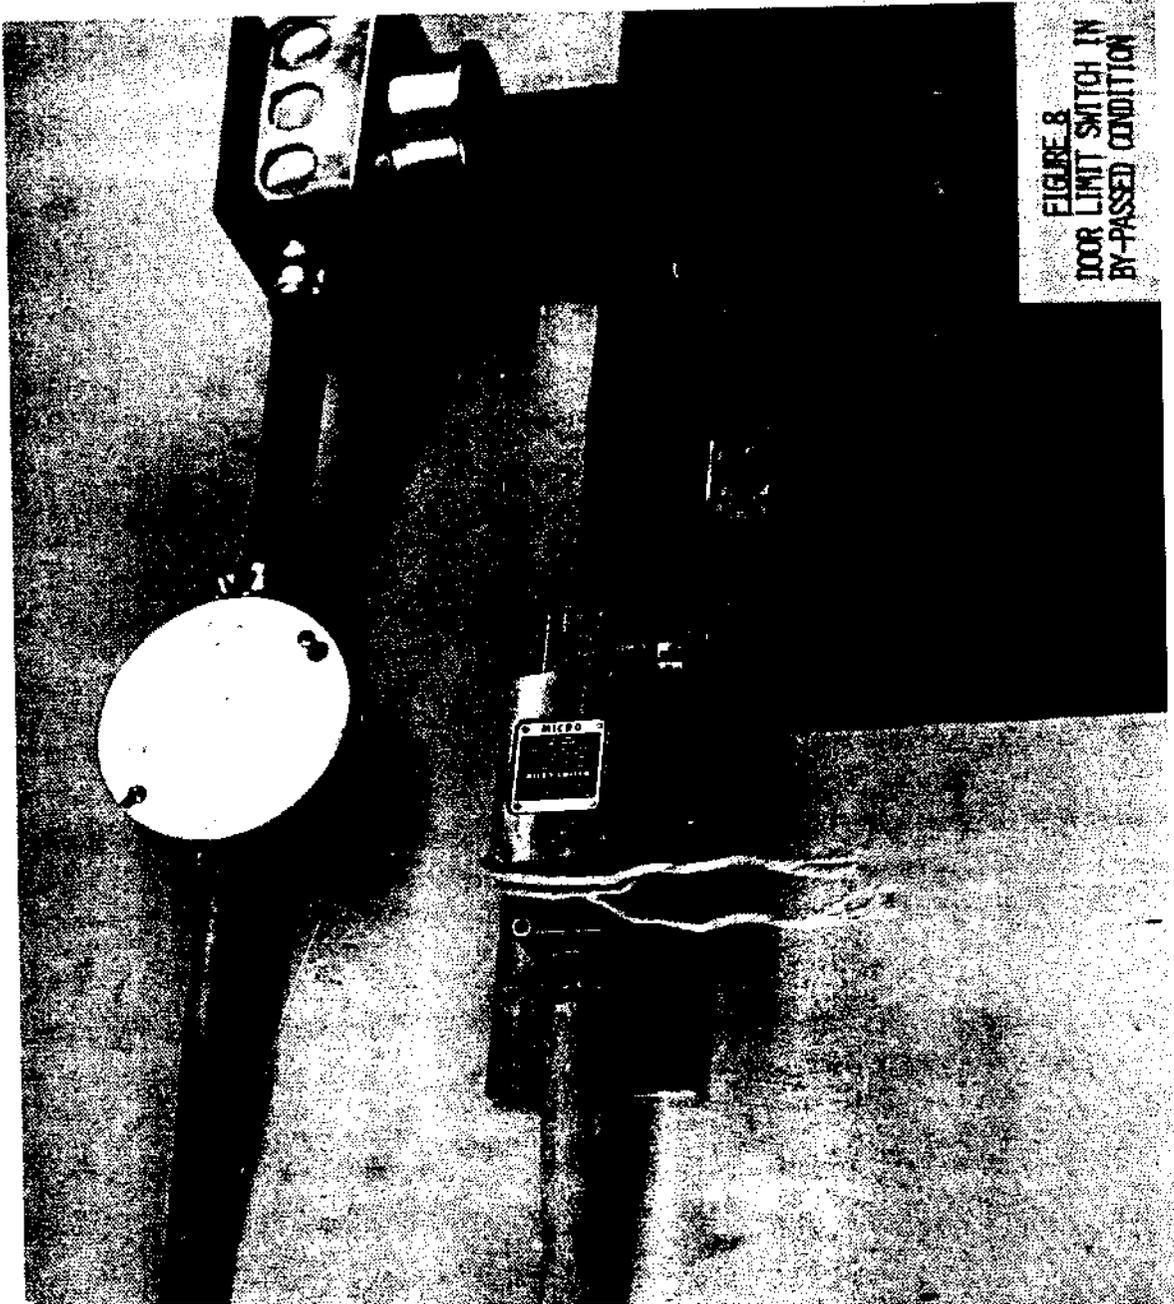
FIGURE 8
DOOR LIMIT SWITCH IN
BY-PASSED CONDITION

At 11:36 A.M., subsequent to the exposure of Employee A, a twelve-minute irradiation was conducted. Prior to initiation of this run, Employee B indicated that he tied the door limit switch closed to permit entry into source room with source raised. During this time, Employees A and B attempted to confirm in their own minds whether or not the exposure had actually occurred. This they did by entering the maze to view the raised source briefly. Employee A indicated that he did not observe whether sources were up or down at time he inadvertently entered room. At 11:48 A.M., the irradiated seed samples were removed and a new set placed in position. During this time, while the source was down, a Victoreen Rate Meter was placed in the approximate position where Employee A would have been exposed. At 11:49 A.M., an eight-minute irradiation period was begun. Information on subsequent events is somewhat confused, but it appears that this exposure period timed out at 11:57 A.M.; samples were again changed and a final irradiation started at 11:58 A.M. Shortly thereafter Employees A and B left the VDRIF for lunch. Employee B went immediately to inform the Laboratory Director of the occurrence and after discussions with the Radiation Safety Officer and further discussions with Employee A, it was decided to send Employee A to the ORAU Medical Division for examination. Employee A was admitted to hospital at about 1:30 P.M.

2. The door limit switch actuator should be modified so that the switch cannot slip past the actuator and falsely indicate that the door is open.
 3. The position indicator system should be replaced or supplemented by a simpler more direct measuring system that does not depend upon the encoder which controls positioning, preferably driven by the drive train downstream of the decoupling mechanism.

- H. It is recommended that strict formal procedures be provided to define conditions under which safety devices may be bypassed. This should include alternative controls and a procedure for assuring bypass removal.

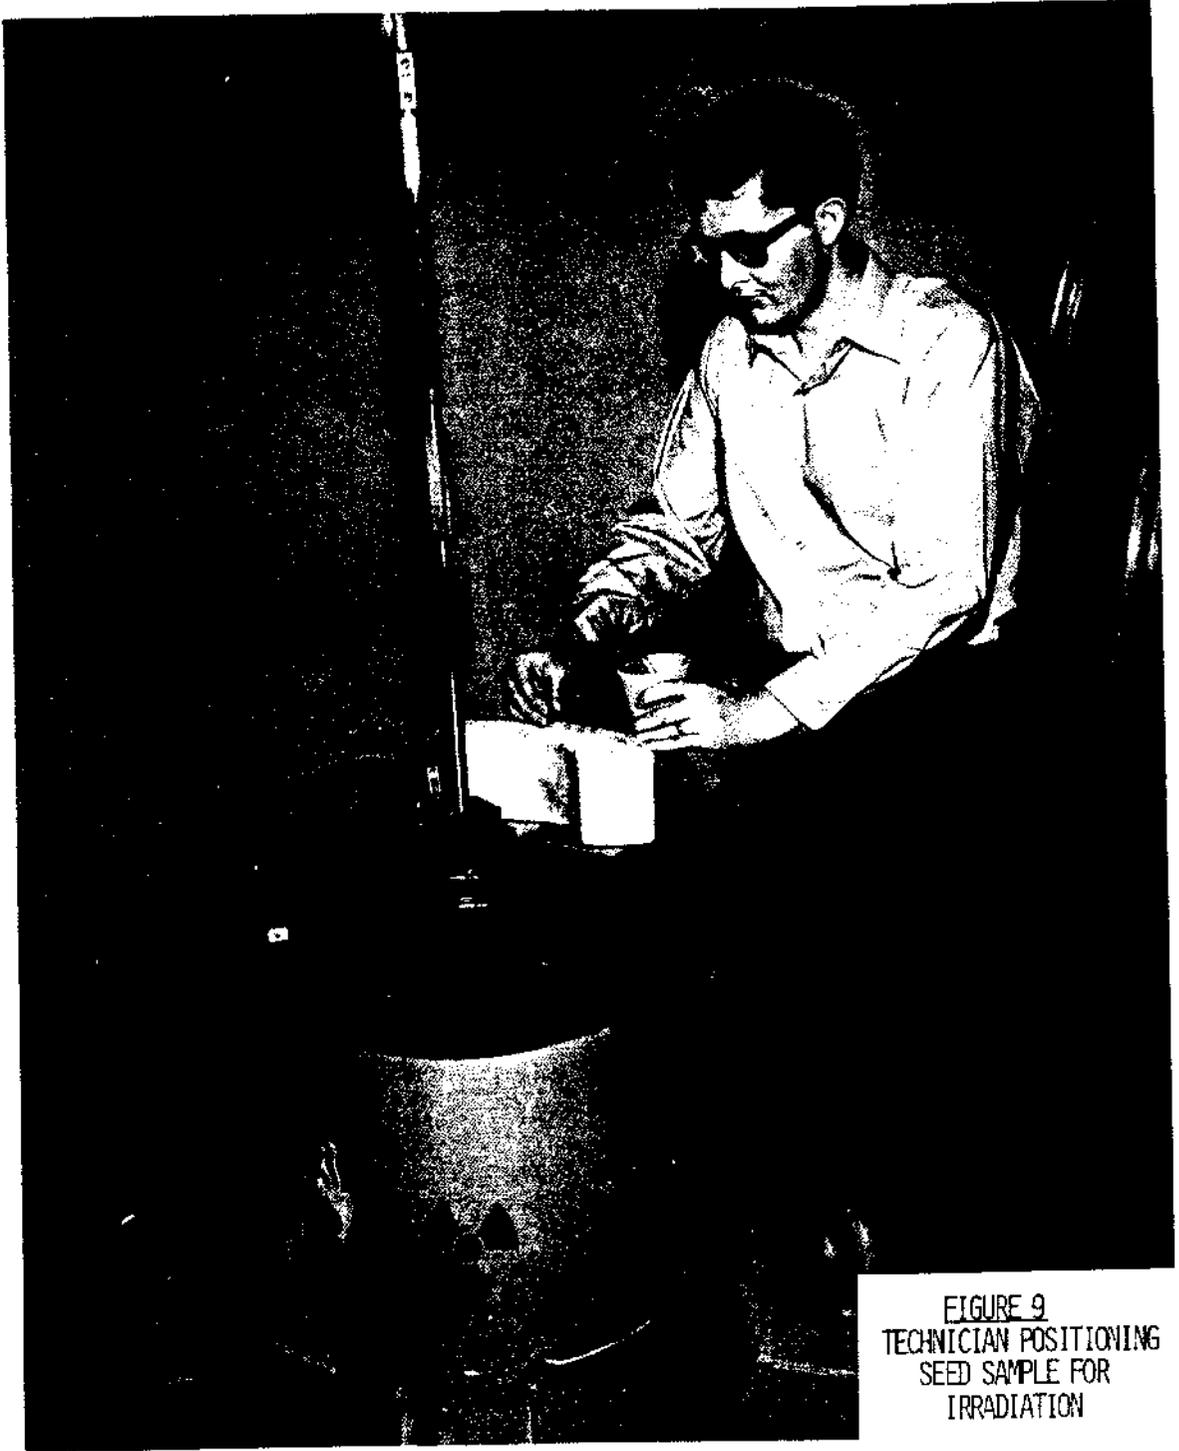
FIGURE 9
TECHNICIAN POSITIONING
SEED SAMPLE FOR
IRRADIATION

disengaged all sources except No. 5 from the drive mechanism which raises the sources since only Source No. 5 was to be used. Employee A meanwhile loaded the four vials for Treatment No. 2. The position of the samples for the experiment is shown in Figure 9.
