## INJURY DUE TO ACCIDENTAL HIGH-DOSE EXPOSURE TO 10 MeV ELECTRONS\*

LAWRENCE H. LANZL and MARTIN L. ROZENFELD  
Department of Radiology and the Argonne Cancer Research Hospital†  
and

**Abstract**—An industrial worker was accidentally exposed to a 10-MeV electron beam from a linear accelerator. Dosimetric information was assembled immediately after the event, and later, through a reconstruction of the accident.

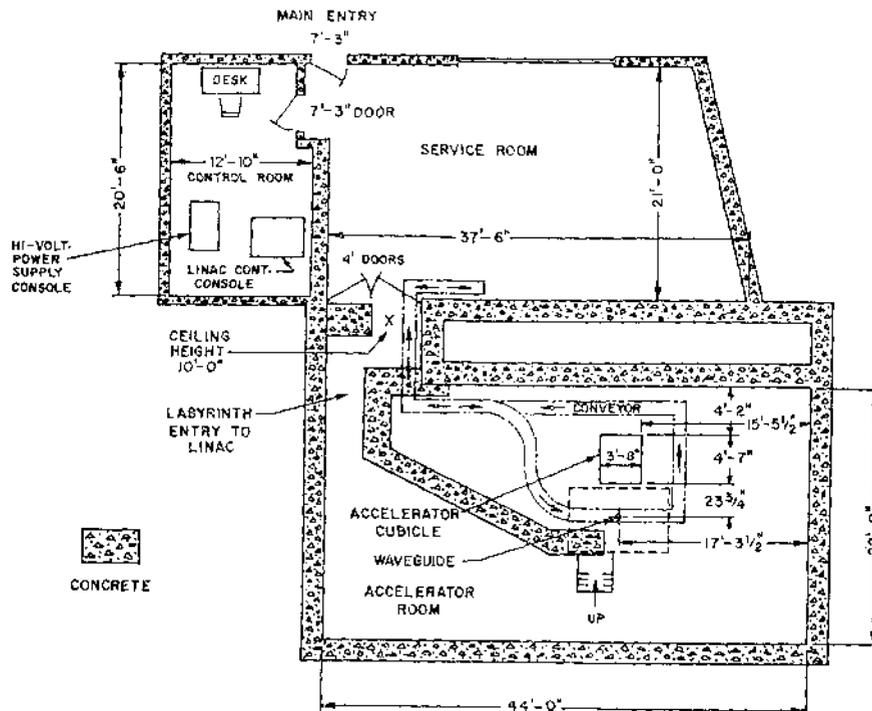
FIG. 2. Schematic drawing of floor plan showing accelerator room, access entryway through radiation labyrinth, service and control rooms. A conveyor belt is capable of transporting industrial products from the service room to the accelerator and then back to the service room.

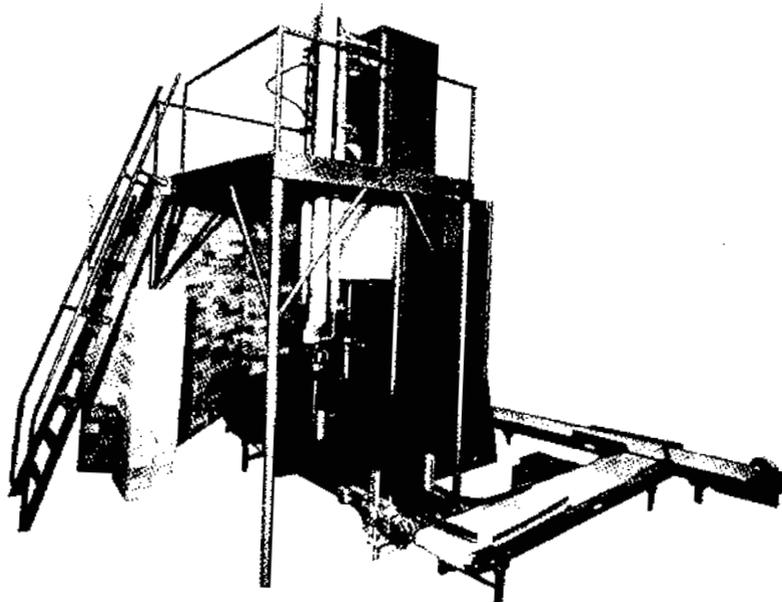
FIG. 1. Over-all view of variable-energy (4-12 MeV) microwave linear accelerator together with conveyor system. The beam is directed downward onto materials placed on the conveyor belt.

As shown in Fig. 1, the accelerator is mounted so that 10.8-MeV electrons are directed downward after emerging into the air from a vacuum chamber at a height of 75 cm from the floor. The maximum peak electron beam current is 200 mA, and the beam pulse length can be varied from 2 to 10  $\mu$ sec. The accelerator is capable of being operated with single pulses or with repetition rates up to 180 pulses/sec. The machine is provided with a scanning system for beam spreading which operates at a scanning rate of 5 c/s. The beam cross-section at the exit window of the scanning chamber is  $3 \times 26$  cm. The beam is scanned across the belt and normal to the direction of the conveyor motion.

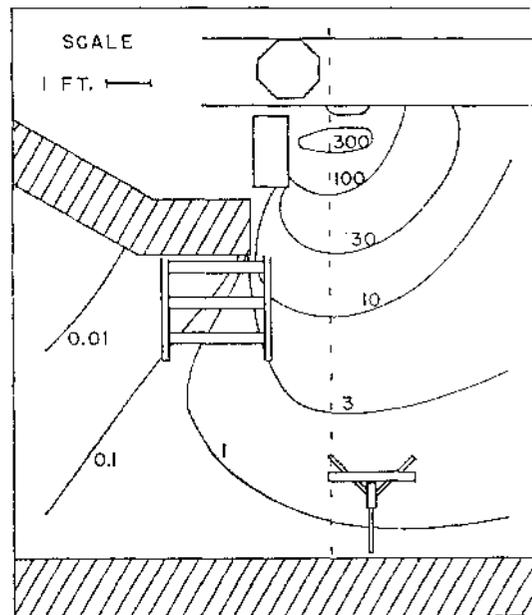
FIG. 3. Schematic drawing of floor plan in the vicinity of the accelerator proper, showing isodose lines at the floor level. The conveyor belt, with the octagonal mold in place, extends across the top of the figure. The vertical dotted line indicates a coordinate system coincident to and extending from the scanning beam location and direction over the conveyor. The rectangular block shown near the conveyor represents the position of a mechanical pump. Parts of the radiation labyrinth are shown in a crossed-line pattern. The location of a ladder (center), a television camera and a bank of lights (bottom) is also indicated. Absorbed dose in rad/sec.

Figure 3 is a partial floor plan sketch with isodose rate lines at the floor level. These dose rates are those for the beam current used in the routine production operations of the accelerator.

The entranceway through which the worker passed is on the lower left of the figure. The conveyor system runs across the top of the figure. The octagonal mold which the worker carried to the conveyor belt is shown in the position in which he left it. The mold contained an industrial product to be irradiated. The dotted line running vertically in the sketch indicates one axis of a coordinate system set up to facilitate recording of data on the placement of radiation detectors about the accelerator. This axis coincides with the direction of the beam scan over the conveyor.

The dose rate levels were measured by means of lithium fluoride thermoluminescent dosimeters calibrated at the equilibrium depth in a water-like phantom against a collimated beam of cobalt-60  $\gamma$ -rays. These dosimeters, together with a Controls-for-Radiation reader,\* are convenient since they function over several decades, and since the reader can be switched to the proper decade range after heating the dosimeters, but before read out. An inter-comparison at several points in the electron field and in the cobalt-60  $\gamma$ -ray field was made with Sievert-type ionization chambers. It was found that the ratio of response in the electron and gamma radiation fields was the same for both types of dosimeters.

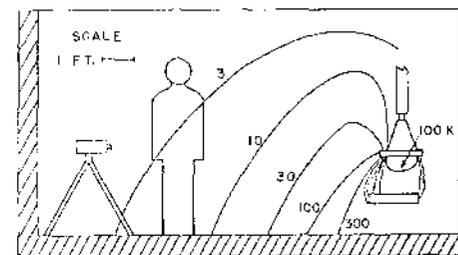
FIG. 4. Isodose lines in a vertical plane as defined by the dotted line in Fig. 3. The end of the accelerator, scanning chamber and conveyor are shown on the right. A television camera and a bank of lights are on the left. The silhouette of the man is shown for scaling purposes only. The isodose lines in the high gradient region just to the left of the accelerator were not labeled for lack of space. Their values are 1K, 3K, 10K and 30K rad/sec respectively.

Figure 4 is a sketch of the accelerator, scanning

chamber, and conveyor on the right side. The left side of the picture shows the location of a television camera and a bank of lights. The figure of the man does not indicate the location of the worker during irradiation, but shows scale only. The isodose rate curves in this figure were determined by thermoluminescent dosimeters in the range of 1000 rad/sec and lower. The higher isodose rate levels around the exit end of the accelerator and conveyor were determined by cobalt-glass dosimetry.\* This method involves the change in optical density at 5300 Å following irradiation of the glass. These data were calibrated by means of a

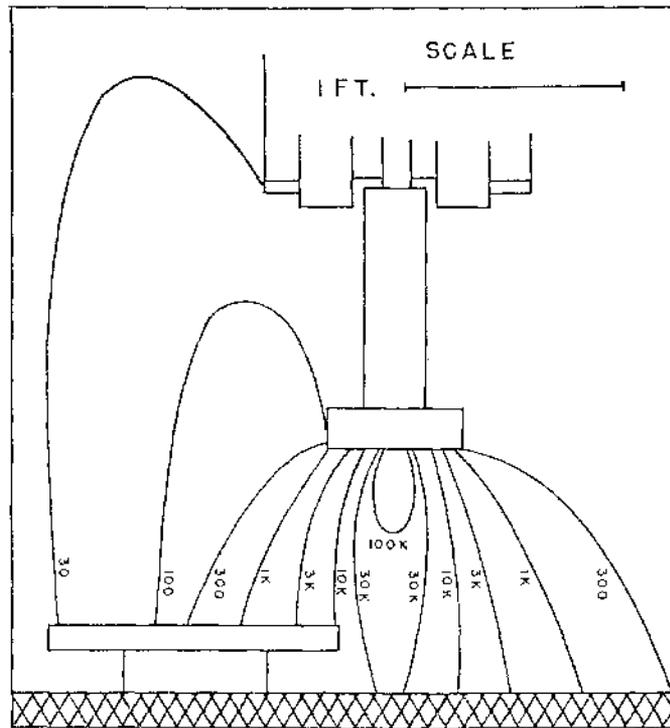
FIG. 5. Isodose lines in a vertical plane at right angles to the dotted line in Fig. 3 and in the mid line of the conveyor belt. The accelerator and the scanning coils are at the top. The scanning chamber is in the center. The cross-hatched lines indicate the conveyor. The mold as positioned by the worker is shown on the lower left. He was facing the belt in the same direction as the reader, so that his left hand was in the 30 rad/sec region and his right hand in the vicinity of the 10K-30K rad/sec region.

Figure 5 is a more detailed sketch of the equipment and of the isodose rate lines in the radiation field. The view is in a vertical plane normal to that shown in Fig. 4. An edge-on view of the scanning chamber is shown in the center of the picture. The mold is in the position on the lower left, where it was placed during the accident. The conveyor belt extends over the entire bottom of the picture. The conveyor belt was not moving before, during or following the accident. This fact enabled us to determine the location not only of the worker's hands but also

of his body during exposure. It is to be noted that the mold was placed on a brick which was directly on top of the conveyor. The worker's left hand grasped the mold on the left side in the dose region of 30 rad/sec, and the right hand, on the right side, in the dose region of 10 K-30 K rad/sec. The mold was held with the thumb on top of the mold and the fingers curled underneath. Thus, the fingers received some radiation protection from the mold. Of course, when the mold was released by the right hand, the fingers presumably swept through the fringe beam without the benefit of this shielding.

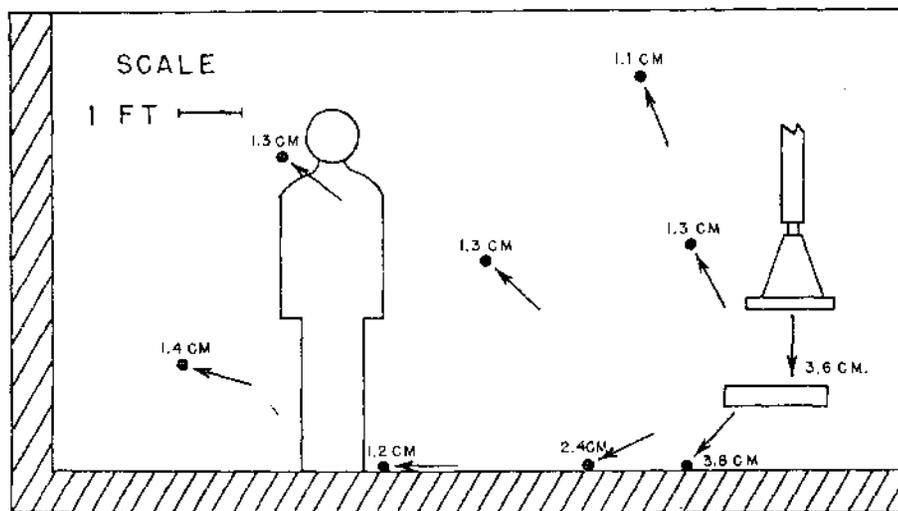
FIG. 6. The direction of the scattered electron beam at various locations in the same plane as Fig. 4 is given by the arrows. The arrow pointing down on the right side of the sketch shows the direction of the primary beam as it leaves the accelerator and scanning chamber and strikes the conveyor belt. The numbers at each arrow location indicate the depth of the 50 per cent dose point of the beam, measured using a tissue-equivalent phantom (see text).

electrons, a simple circular phantom of unit density was used with Adlux\* film as a detector. This film was chosen because of its low sensitivity. The phantom was constructed of a stack of 8-cm diameter Masonite disks with circular pieces of film placed between the disks. The results of the measurements are shown in Fig. 6. The crescent shape of the blackening on all the films indicates a high order of unidirectionality of the scattered electrons, the source of scatter being the conveyor. The direction (see Fig. 6) of the scattered electrons at various locations is indicated by the arrows. This view is in the same plane as shown in Fig. 4. The arrow pointing down on the right side of the sketch shows the direction of the primary beam as it leaves the accelerator and scanning chamber and strikes the conveyor belt. The numbers at each arrow indicate the depth of the 50 per cent dose level of the beam.

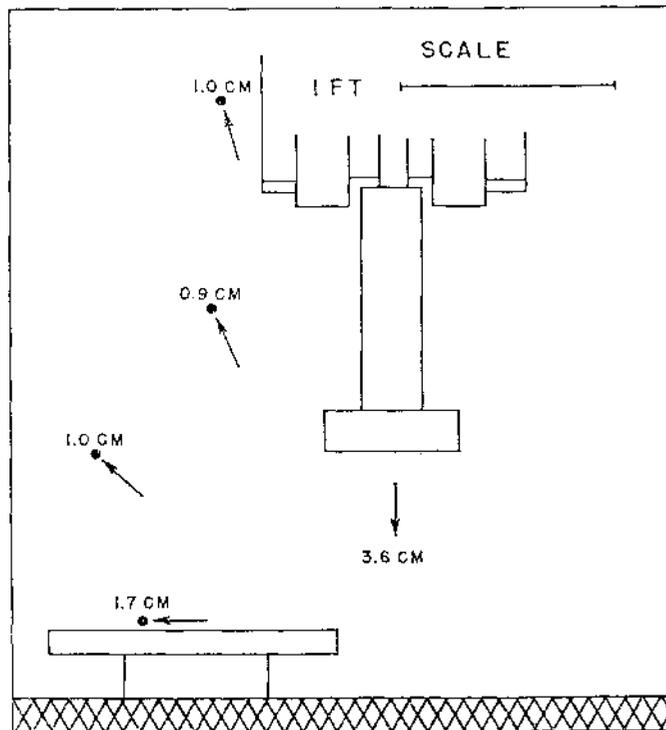
FIG. 7. Direction of the scattered electron beam at various locations in the same plane as Fig. 5. The arrow pointing down in the lower center of the figure shows the direction of the primary beam as it leaves the scanning chamber. The conveyor belt and the mold position are shown at the bottom of the sketch.

Figure 7 shows the direction of the scattered electron beam and depth of the 50 per cent dose at various locations in the same plane as Fig. 5. The arrow pointing downward in the lower center of the figure shows the direction of the primary beam as it leaves the scanning chamber. The conveyor belt and the mold position are shown at the bottom of the sketch.

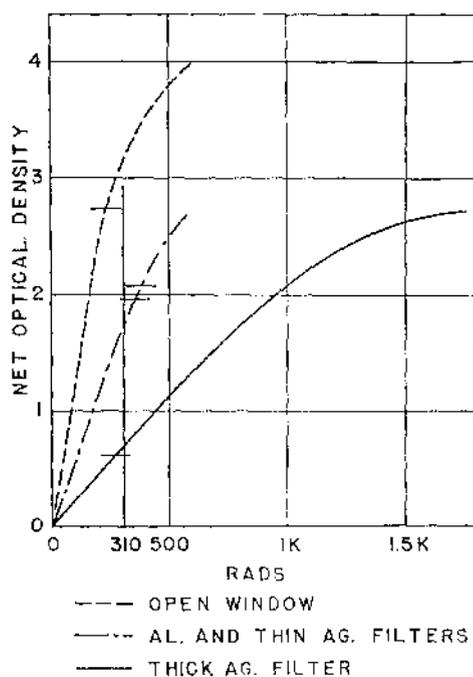
FIG. 11. Calibration curve of personnel film badge. Net optical density is plotted against dose. The net optical density readings of the accident exposure are shown as a series of four short horizontal lines. An average of these readings gives a dose of 310 rad to the film badge, i.e. skin.

The dosimeter readings showed that the skin on the anterior and right lateral surfaces of the trunk of the body received doses in the range 245–325 rad. The interior of the body received doses ranging from 0.2–5 rad. These measurements of interior dose levels, determined through a reconstruction of the accident, were consistent with estimates made immediately after the accident based on preliminary readings of the victim's film badge and calculations of bremsstrahlung formation in the skin of the chest from a highly scattered electron beam. These early estimates had provided great confidence that the injured person would survive, since the blood-forming tissues would not have been impaired at this dosage level.

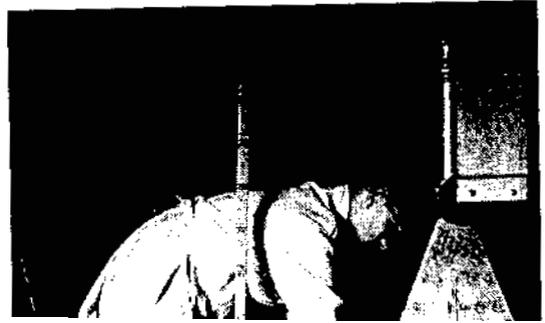
FIG. 20. Radiography of the right hand of an average male of the same age as the injured worker presented for comparison with Fig. 19.

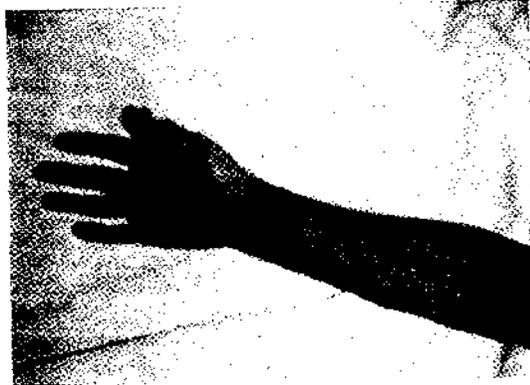
FIG. 13. Right hand, 19 February 1965, 11.00 a.m., Day 2.

Figures 13 and 14\* show the hand at 11.00 a.m. on 19 February (Day 2). There is erythema over the entire hand and the distal third of the forearm. Swelling was most marked about the thumb, beginning at its base and extending backward to the mid-forearm. Later that day, the patient described a burning sensation at the wrist between the thumb and index finger. On the following day, he complained that this thumb felt cold. On Day 4, 21 February, two bullous lesions, 3 × 4 cm and 2 × 2 cm, appeared on the dorsal surface of the right thumb, extending to the index finger. Medication was necessary to control pain. Although movement of the fingers was limited by swelling, there appeared to be no neurological deficit on Day 5.

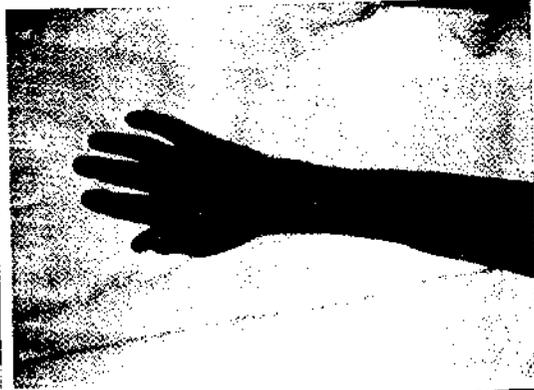
14

FIG. 14. Right hand, 19 February 1965, 11.00 a.m., Day 2. There is erythema over the entire hand. Swelling is most marked about the thumb, beginning at the base and extending to the mid-forearm.

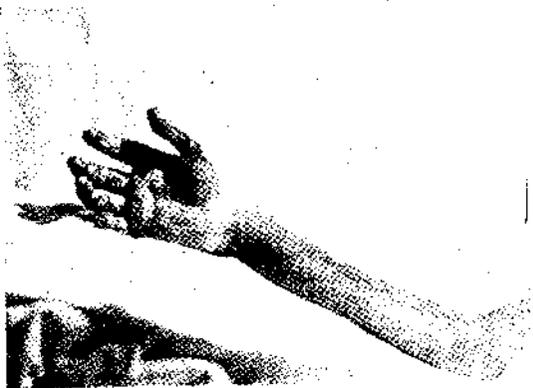
FIG. 15. Right hand, 24 February 1965, 11.00 a.m., Day 7. The white material in this and subsequent photographs is from an ointment that was incompletely removed during cleansing before photography. Bullae which formed over the thenar and hypothenar eminences are clearly visible.

Figures 15 and 16 are photographs taken on Day 7. By Day 8 the swelling had extended to the axilla and involved the anterior axillary folds and anterior chest wall. All sensation in the thumb had vanished, except for pain on movement at the metacarpal phalangeal joint. Bullae formed over the thenar and hypothenar eminences and extended into the palm. The skin over the thenar eminence turned white and the tissue below had a bluish hue. The right leg continued to show only mild erythema laterally.

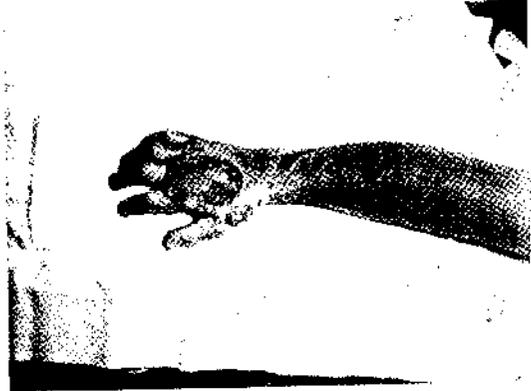
16

FIG. 16. Right hand, 24 February 1965, 11.00 a.m., Day 7.

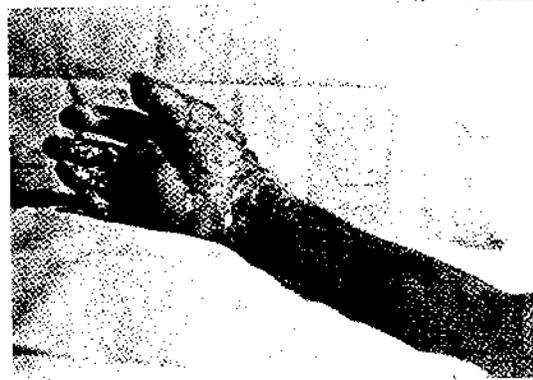
FIG. 17. Right hand, 28 February 1965, 10.00 a.m., Day 11.

On Day 9 the bullous lesions over the base of the thumb and palm continued to enlarge and weep serous gelatinous material. The enlargement, but not the weeping, ceased by

Day 11 (see Figs. 17 and 18). Edema appeared to be on the decrease, but still extended to the axilla.

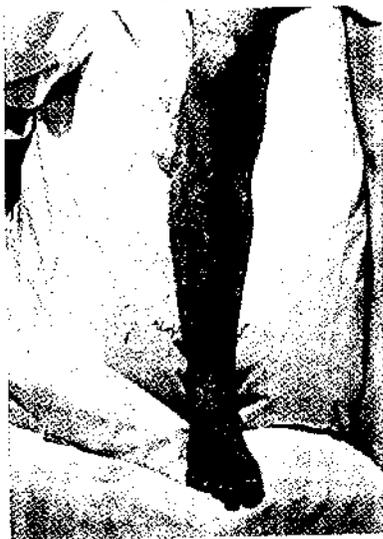
21

FIG. 21. Right foot, 28 April 1965, Day 70. Generalized erythema of the foot appeared on Day 30. Onset of tissue injury in the foot occurred later than that of hand because of the lower dose to the foot.

The delayed tissue response and the necrosis occurring after radiation injury are well illustrated by the course of events in the right foot and leg. Erythema of the anterolateral surface of the leg was present on the day of exposure, but remained stationary for twenty days before the skin broke down. Similarly, the foot appeared completely normal until Day 25, when small vesicles appeared about the nail beds. Generalized erythema of the foot appeared on Day 30, with breakdown of the skin on Day 35 (see Fig. 21, Day 70). Neuro-muscular function was intact. Severe pain was treated effectively with another percutaneous cervical chordotomy aimed at the pain fibers from the lower extremity. After 3 months of observation and surface cleansing, surgical debridement was begun. Repeated discouragement was experienced as tissues that appeared to be viable one week became necrotic the next. Slow, but progressive loss of structure and loss of function of the deeper tissues followed, necessitating amputation just above the knee on 24 August, 6 months after exposure.
