**AEC Investigation of Cobalt-60 Exposure
at the
Variable Dose Rate Irradiation Facility, UT-AEC**

(Report of Investigating Committee)

February 4, 1971

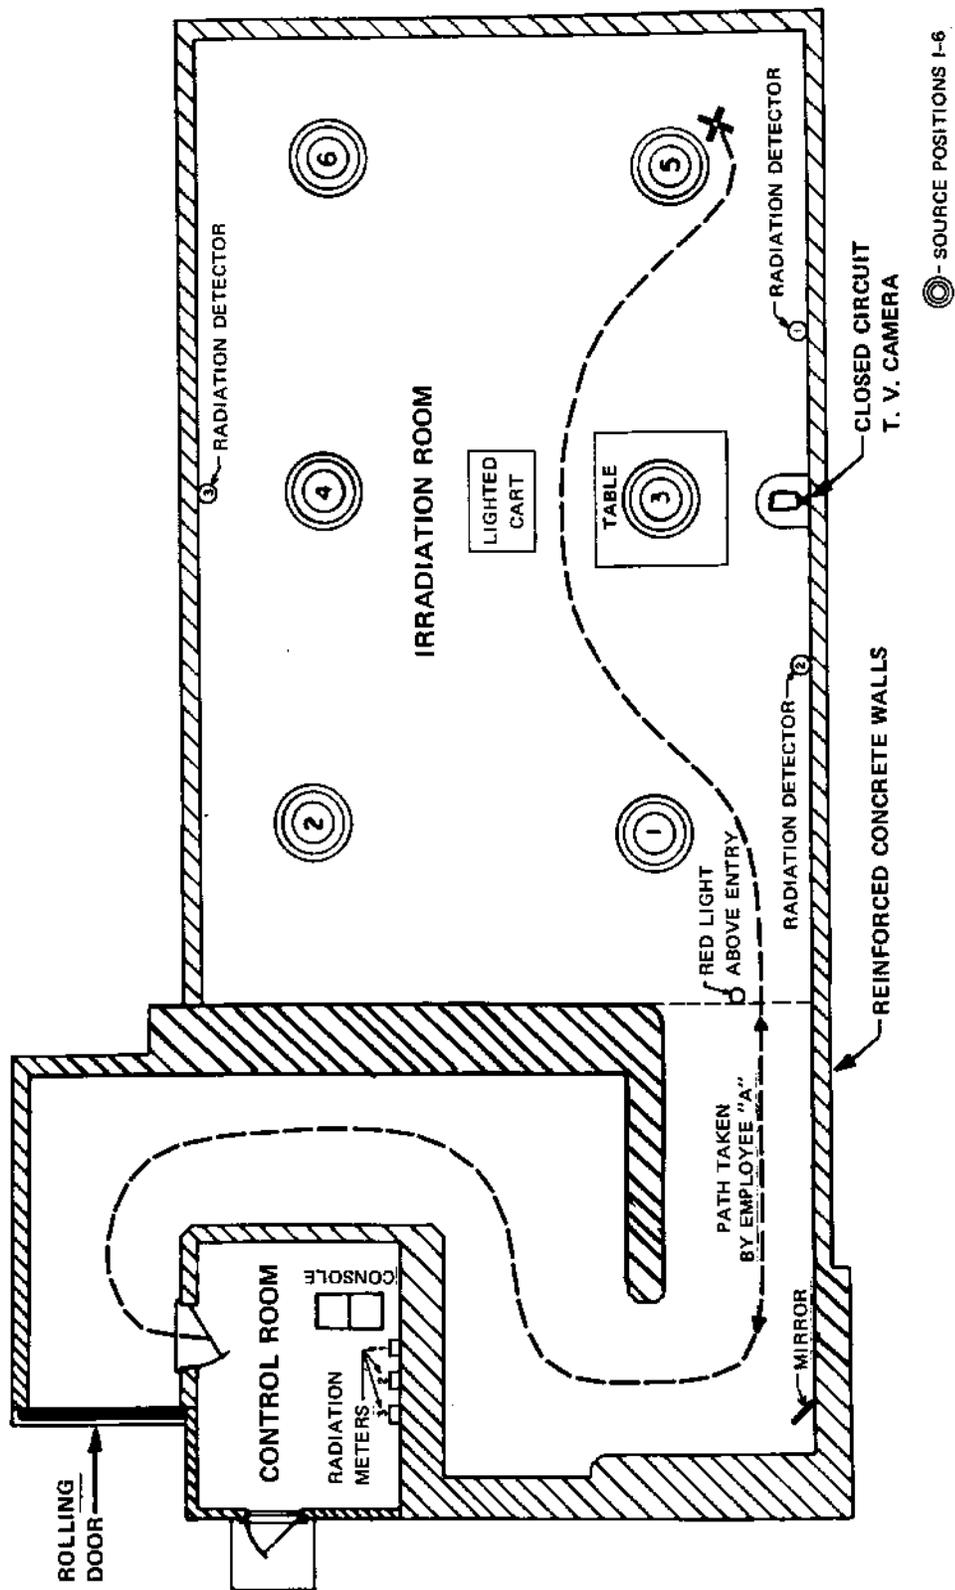
FIG 1 - VARIABLE DOSE RATE FACILITY - FLOOR PLAN

The Variable Dose Rate Irradiation Facility (VDRIF) is housed in a building (see Figure 1) approximately 90 ft by 40 ft, with 12" concrete walls on three sides. Earth shielding is used on these sides and the roof, with the exposed front of the building being shielded by at least 4 ft of concrete. The control room is connected to the irradiation room by a maze which is shielded from the sources by a 4 ft thick wall. Access to the maze is through a personnel door (see Figure 2) from the control room and an electrically operated roll-up door adjacent to the control room. A second door to the control room serves as the main building entrance.

It is assumed that the exposure received while approaching and leaving position X (See Figure 1) was negligible.

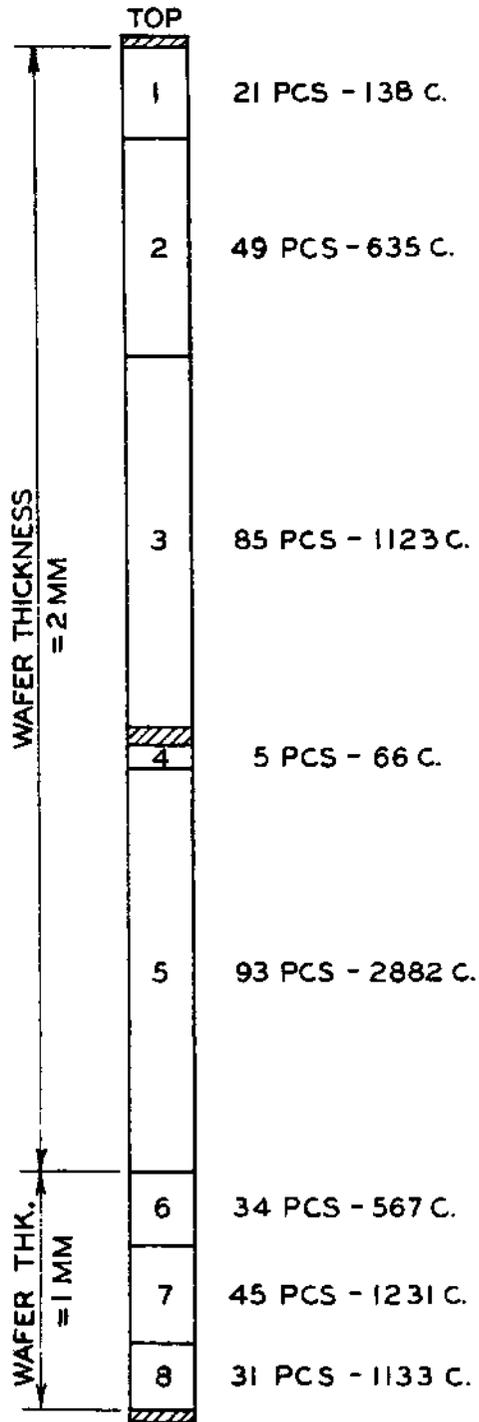
FIG. 4
SOURCE LOADING PLAN

Inside the irradiation room are the 6 Cobalt-60 sources, normally stored in their shielded containers which are located on 20 ft centers in a rectangular 2 x 3 array (see Figures 1 and 3). Each source contains approximately 8,000 curies distributed as shown in Figure 4. Any or all of the sources may be attached manually to the drive train prior to an irradiation. After the appropriate sources are attached and the irradiation targets are placed in position, the facility operator goes from the irradiation room to the control room, from which he can raise and lower

the attached sources remotely, with control of elevation and exposure time being achieved by a "program controller," as described later. When fully withdrawn (850 mm) the bottom of the active portion (Figure 4) of a source is approximately 90 cm above the floor. Since the top of the shield is approximately 76 cm above the floor, the bottom of the active portion of the source is then about 14 cm above the top of the shield.

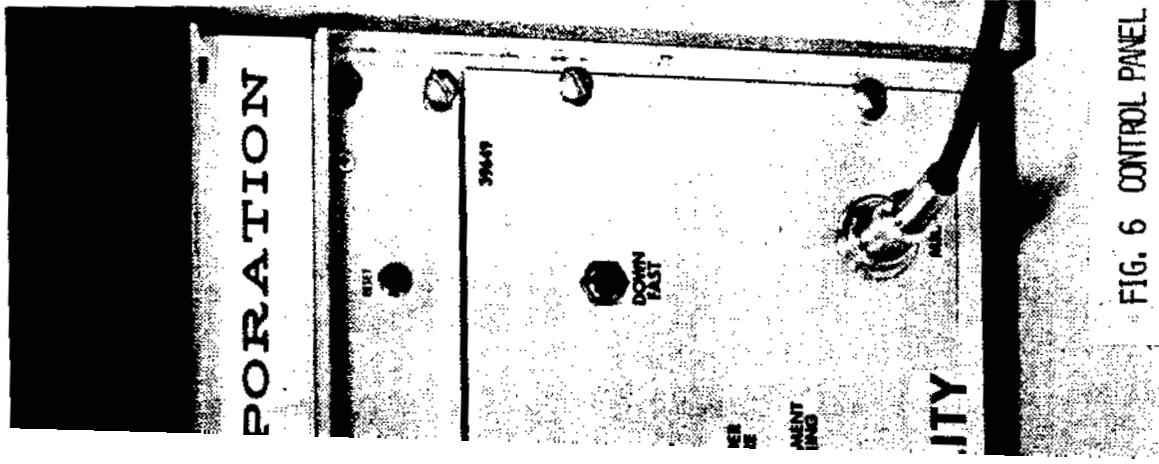
FIG. 6 CONTROL PANEL

There are a number of indicators to facilitate administrative control of access to the maze. They are as follows (see Figures 5 and 6):

The operator has several controls at his disposal as seen in Figure 6. First he can dial a preset position demand and a preset exposure time on digital switches. These read directly in millimeters and minutes or seconds depending on the position of a time base selector. He then can initiate an irradiation, subject to the constraints described above, by turning a key switch on and pushing a "go" pushbutton on the console.

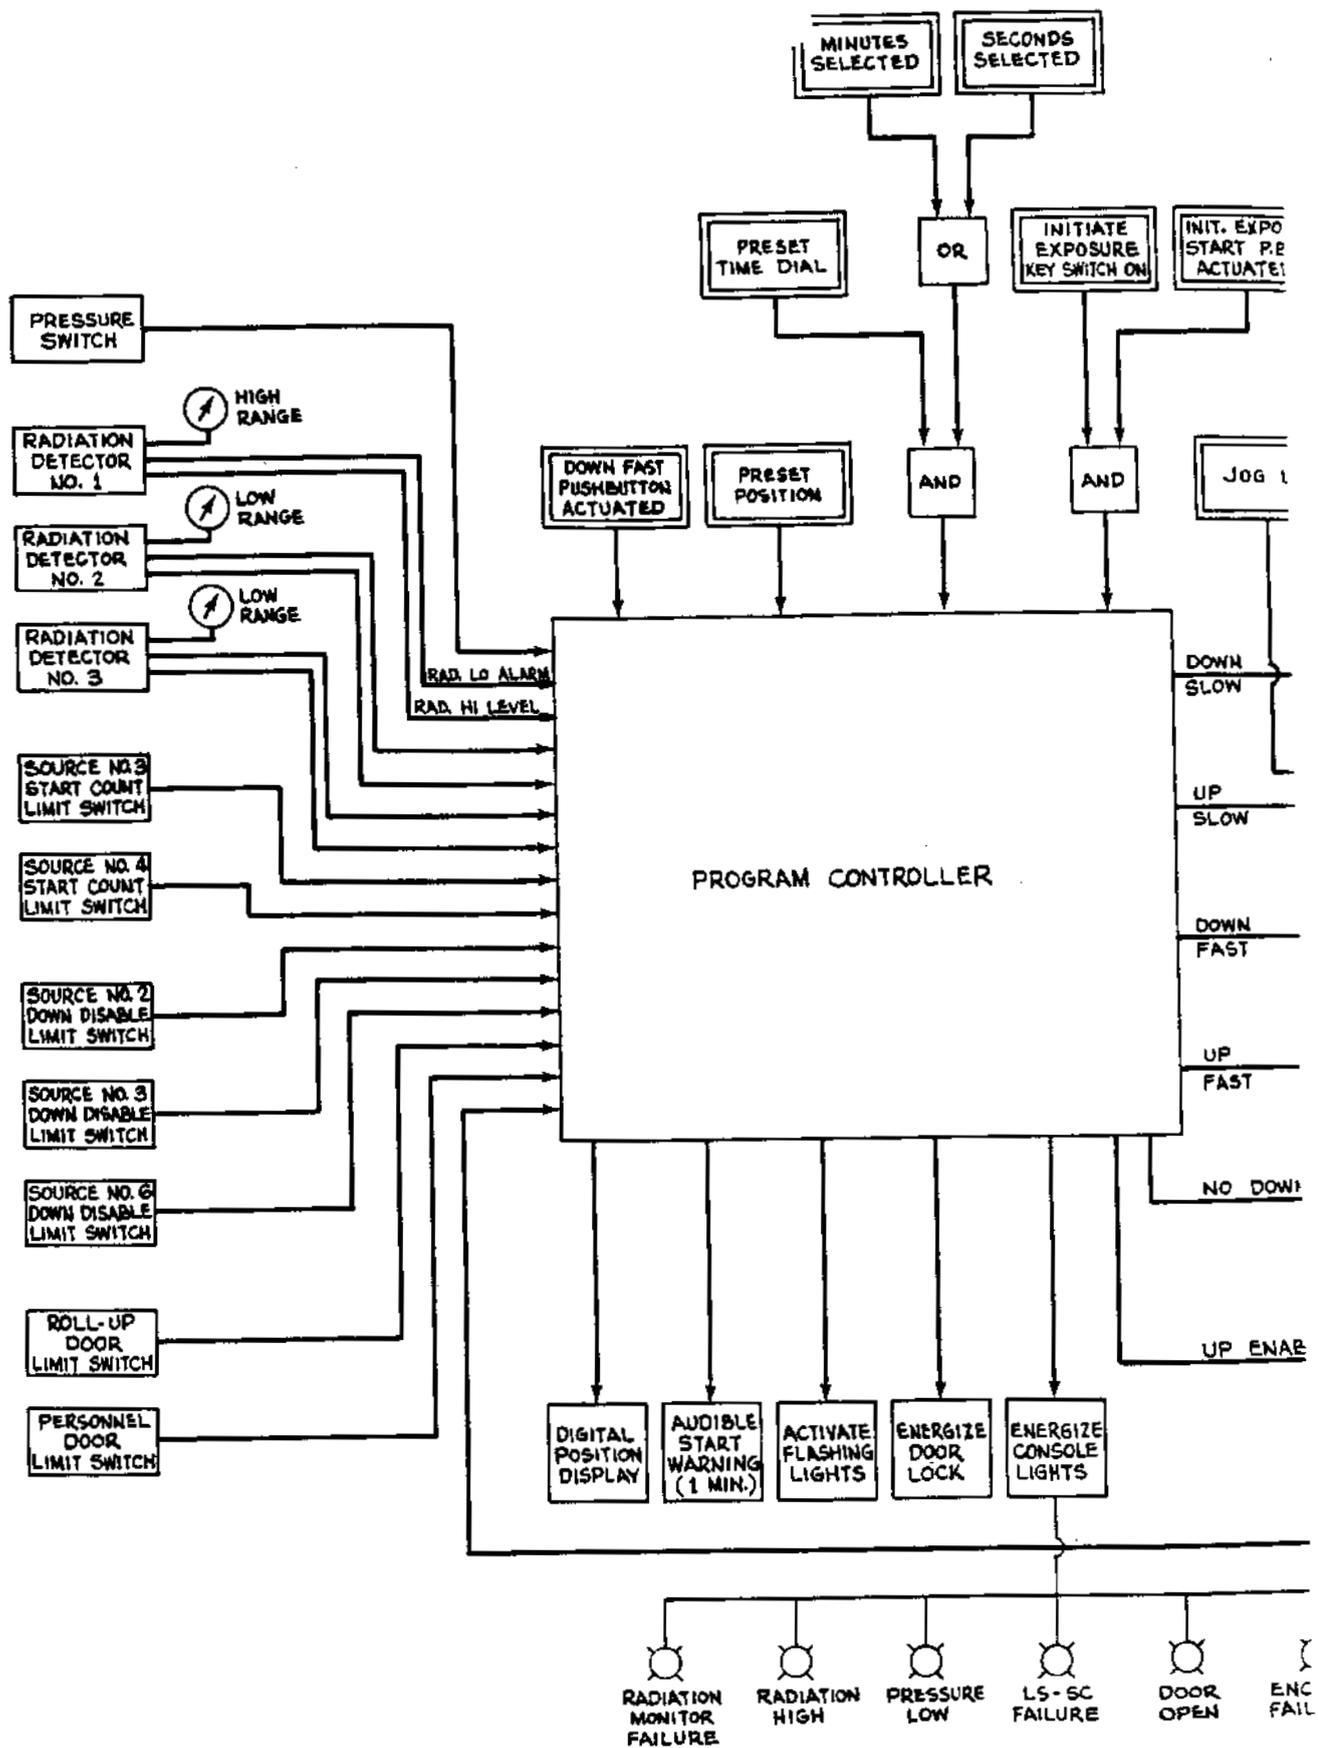
FIGURE 7

The inputs and outputs of the program controller are shown in block form on Figure 7. The block labeled "Program Controller" comprises logic elements and input-output devices which act upon signals entering the block and produce output signals or actions. These outputs are influenced by the current status of the inputs as well as the sequential behavior of the inputs and the logic elements. The breakdown of equipment in block form is more nearly functional than geographic.

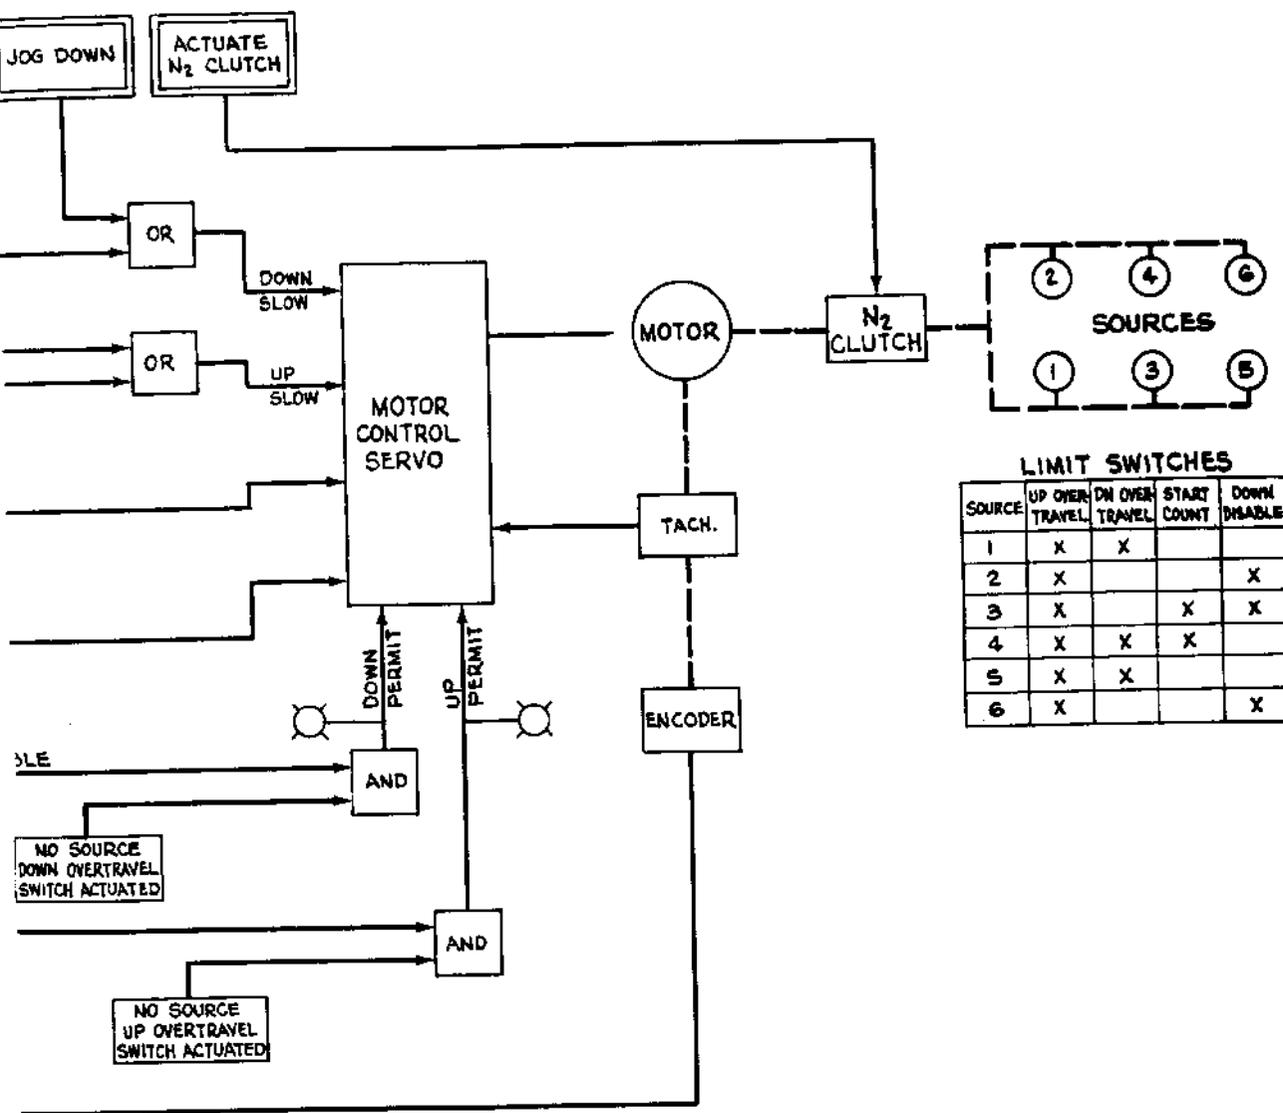
LIMIT SWITCHES

The start count limit switches are located on drives 3 and 4 and serve as fiducial zero references. Each is a single pole, double throw switch which changes aspect as the drive goes through the reference height. The logic system continuously monitors these switches to detect inconsistencies between the two outputs of each switch and between the two switches. Any detected failure energizes a limit switch failure light on the console. This failure would also prevent initiation of a programmed irradiation but would not abort one in progress. Both SC limit switches must indicate that the sources are in their down limits before the operator can initiate the irradiation. As soon as either indicates that the drive has moved out of the limit a "count" condition is established. This count condition remains throughout the irradiation and is primarily an indication that the sources are up and the automatic run is terminated only after both limit switches are restored to their initial state. A condition for the source drives to be driven down by the automatic program or the operator's use of the down fast button is that the "count" state be activated (implying one of the two SC limit switches is in the "drive withdrawn" state). A number of other functions relative to timing and sequencing also are performed.

The down disable limit switches are installed on rods 2, 3, and 6 and are primarily used to prevent the drives from being driven into the overtravel limit at high speed in the event of certain control failures. They are adjusted 30 mm above the normal zero position and the logic arrangement is such that if the drive is operating in the "fast" mode and either of the three is actuated then a signal is generated to disable the down circuit and prevent further motor operation in the direction to lower the sources.

The door limit switches are standard industrial limit switches mounted on the wall of the maze adjacent to the truck door and on the control room wall adjacent to the door to the maze. Metal operators are bolted to the doors and the switch contacts are held closed when the doors are closed. When either door is opened, the appropriate switch contact is opened by spring forces. This action is sensed by the logic system and an "OR" gate is used to energize the "door open" light on the console. The same "OR" gate transmits a "door open" signal to another "OR" gate which is used to generate an "end exposure" signal. The other two inputs to this latter "OR" gate are a "down fast" pushbutton operation by the operator and an "end time" signal from the program timer. If either door is open initiation of a run is inhibited.
